**DEBRIS/ICE/TPS ASSESSMENT and
INTEGRATED PHOTOGRAPHIC ANALYSIS
OF SHUTTLE MISSION STS-108**

Armando Oliu
Process Engineering/Mechanical System Division/ET-SRB Branch,
Kennedy Space Center, Florida

December 5, 2001

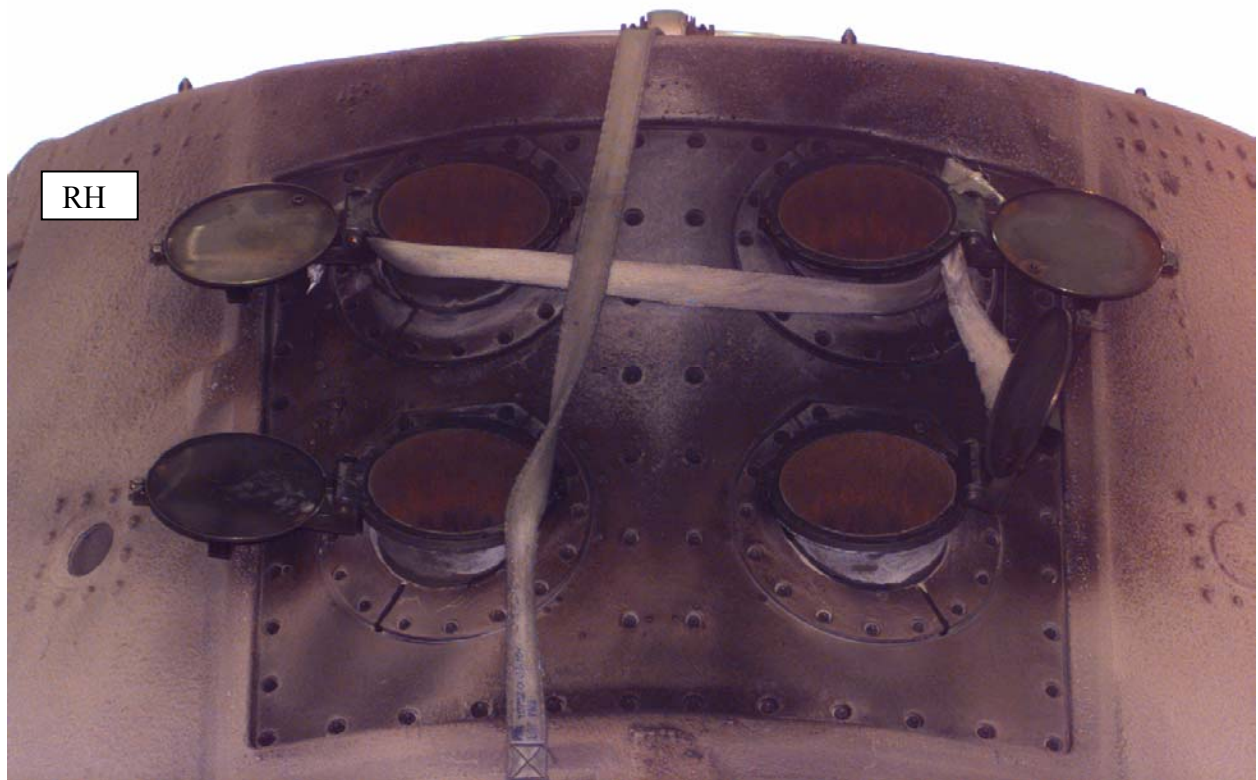
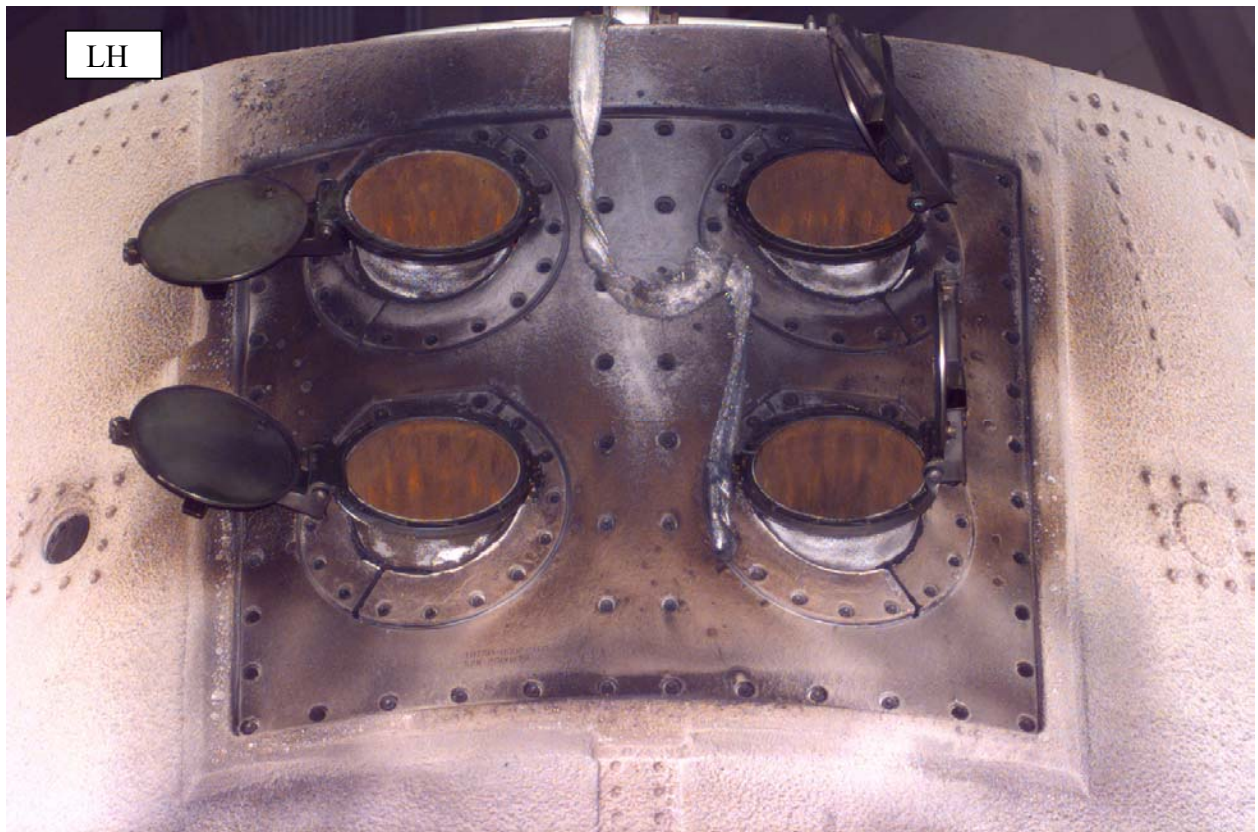
Photo 14: BSM Cover Condition

One RH and two LH cover attach rings had been bent at the hinge by parachute riser entanglement.

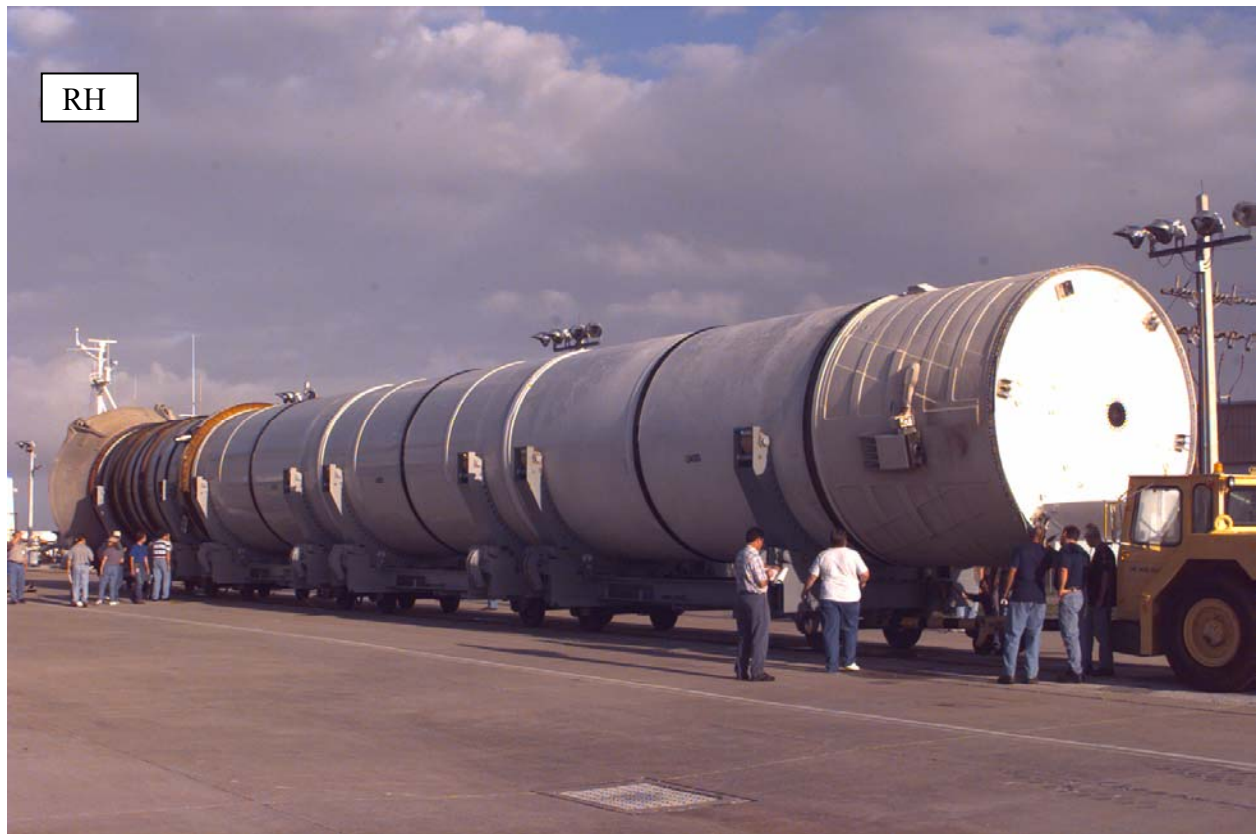
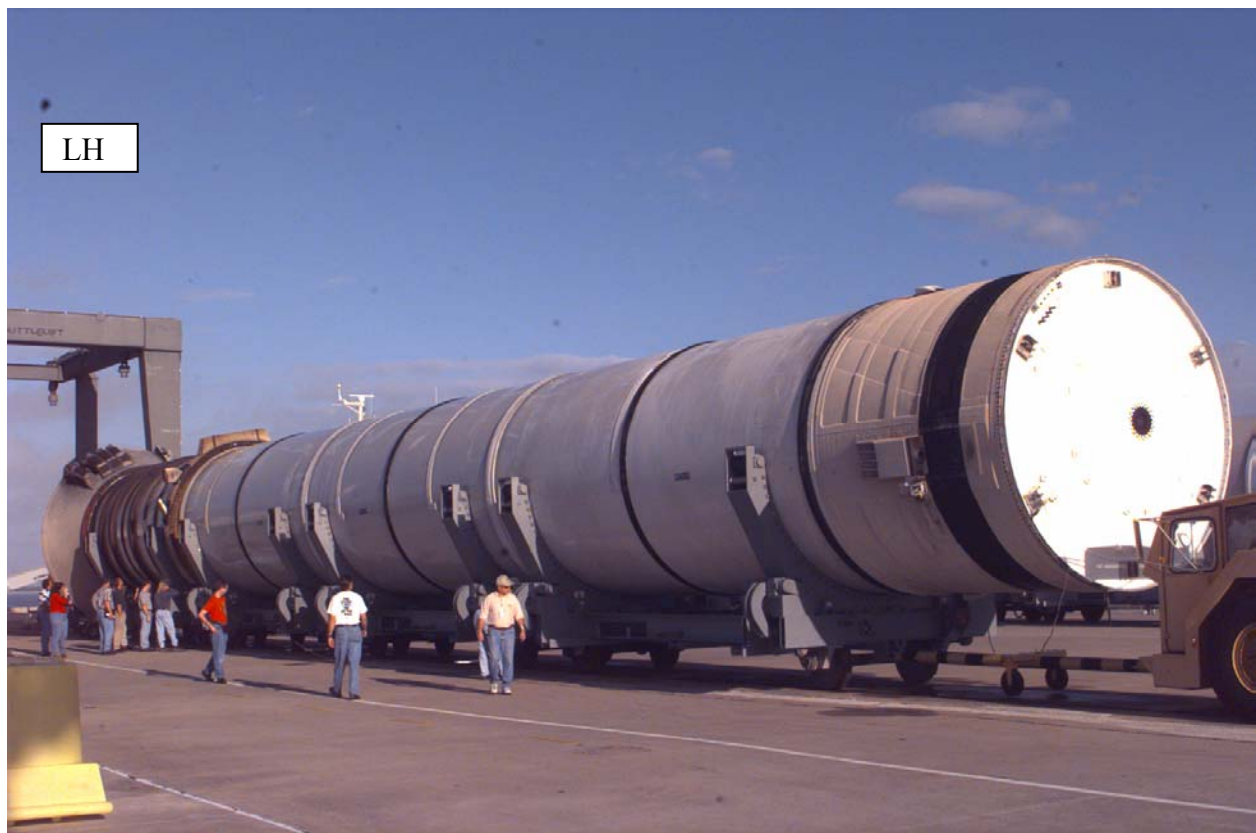
Photo 15: SRB Post Flight Condition

Both SRB's were found in good condition regarding debris assessment

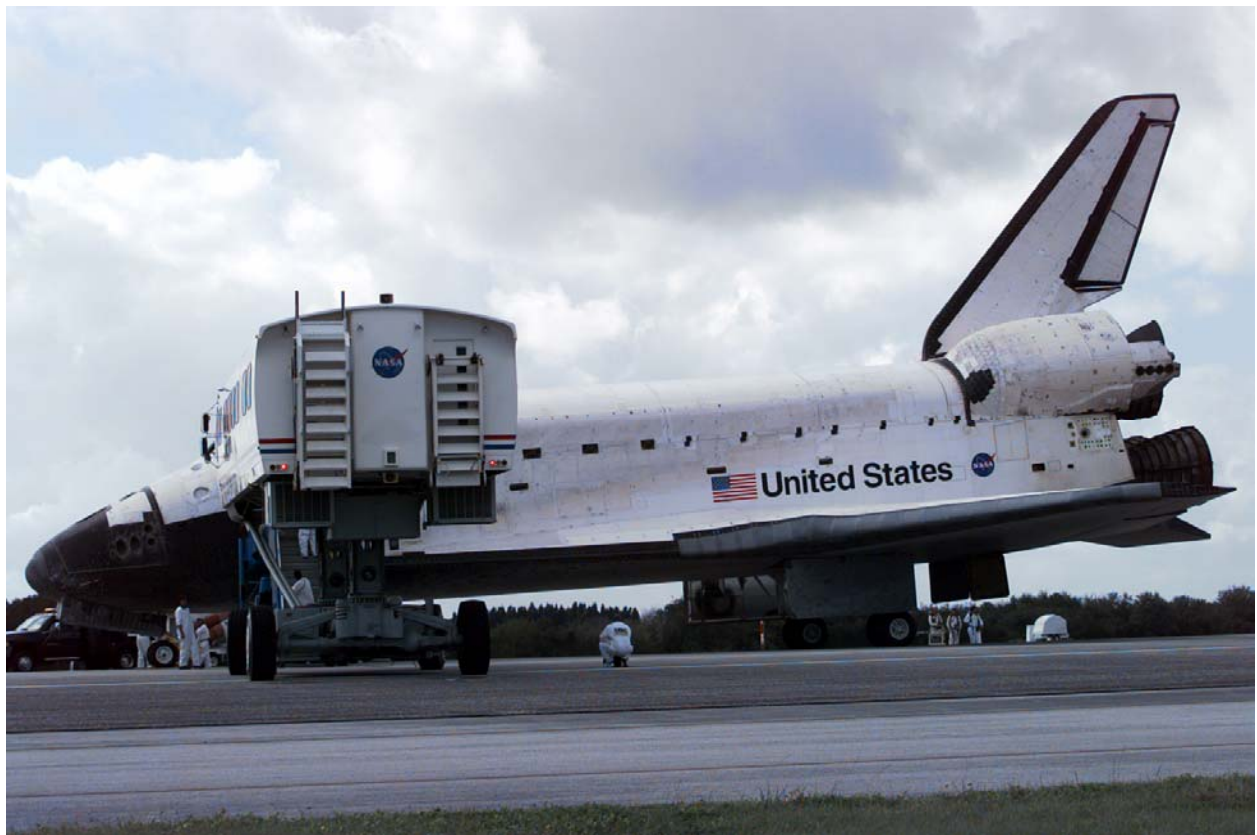
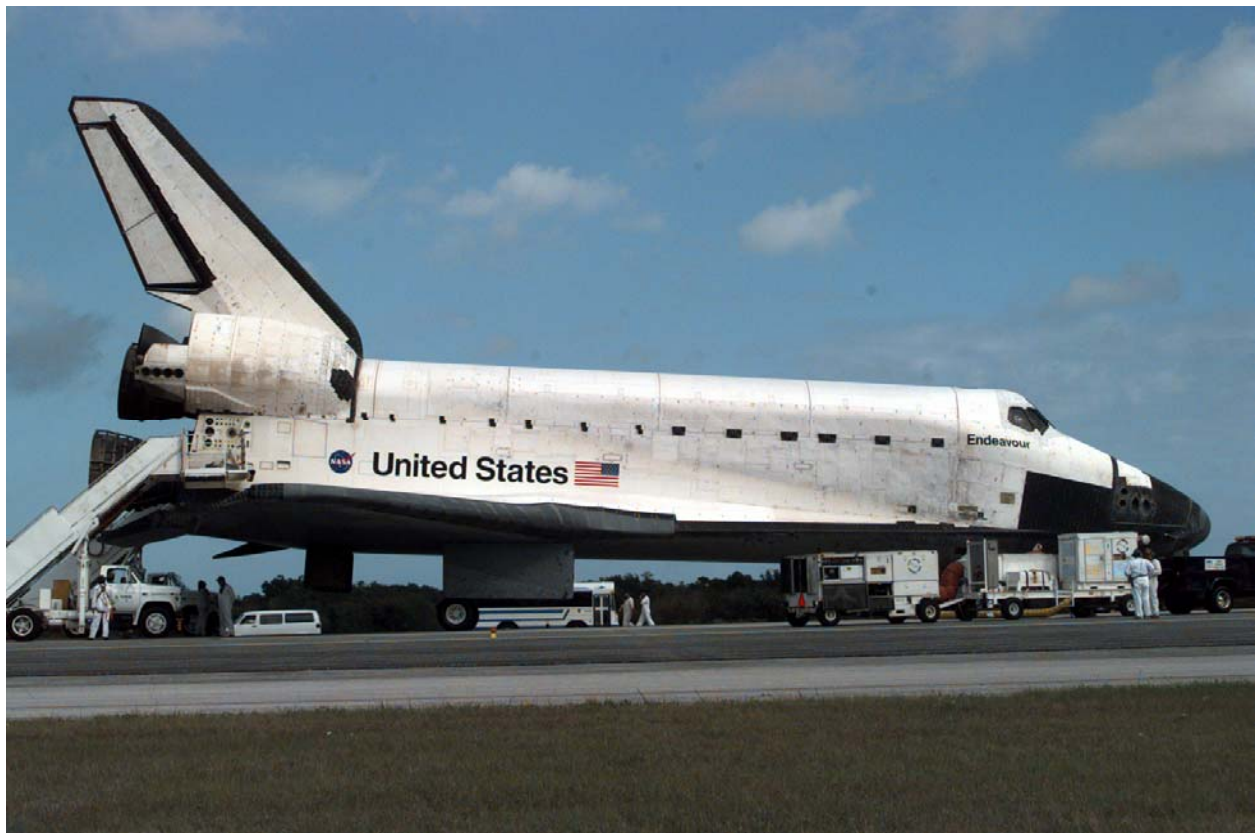
Photo 16: Overall View of Orbiter sides

Post landing inspection of Orbiter tiles showed a total of 95 hits, of which 22 had a major dimension of 1-inch or larger. The Orbiter lower surface sustained 81 total hits, of which 17 had a major dimension of 1-inch or larger, both numbers are within family. The majority of the hits (49 total with 12 greater than 1-inch) were located in the area aft of the main landing gear wheel wells. Most of these damage sites around the ET/ORB umbilical were most likely caused by pieces of the umbilical purge barrier flailing in the airstream and contacting tiles before pulling loose and falling aft.

The Orbiter TPS sustained a total of 95 hits of which 22 had a major dimension of 1-inch or larger. Both the total number of Orbiter TPS debris hits and the number of hits 1-inch or larger were within established family.

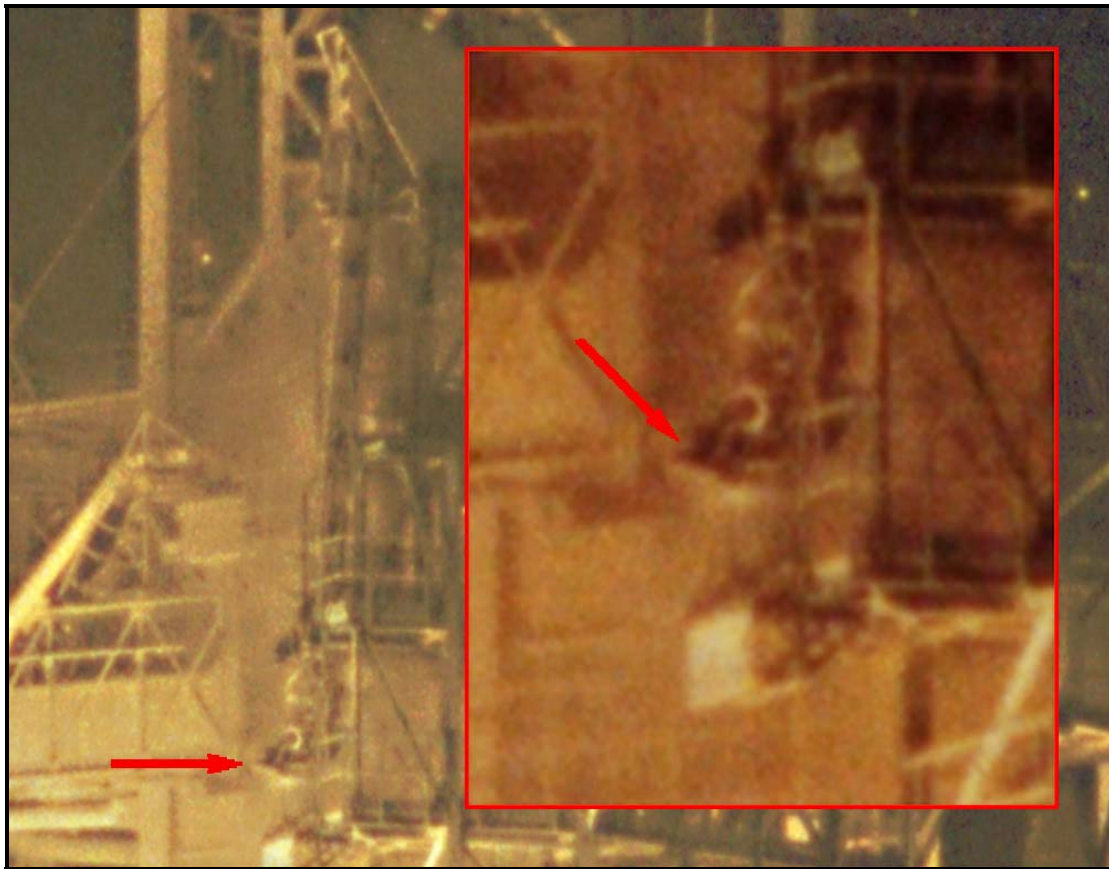
**Figure 2.1.1 GH2 Vent Arm at Point of Maximum Rebound
(Camera E60, Time 22:19:31.029 UTC)**

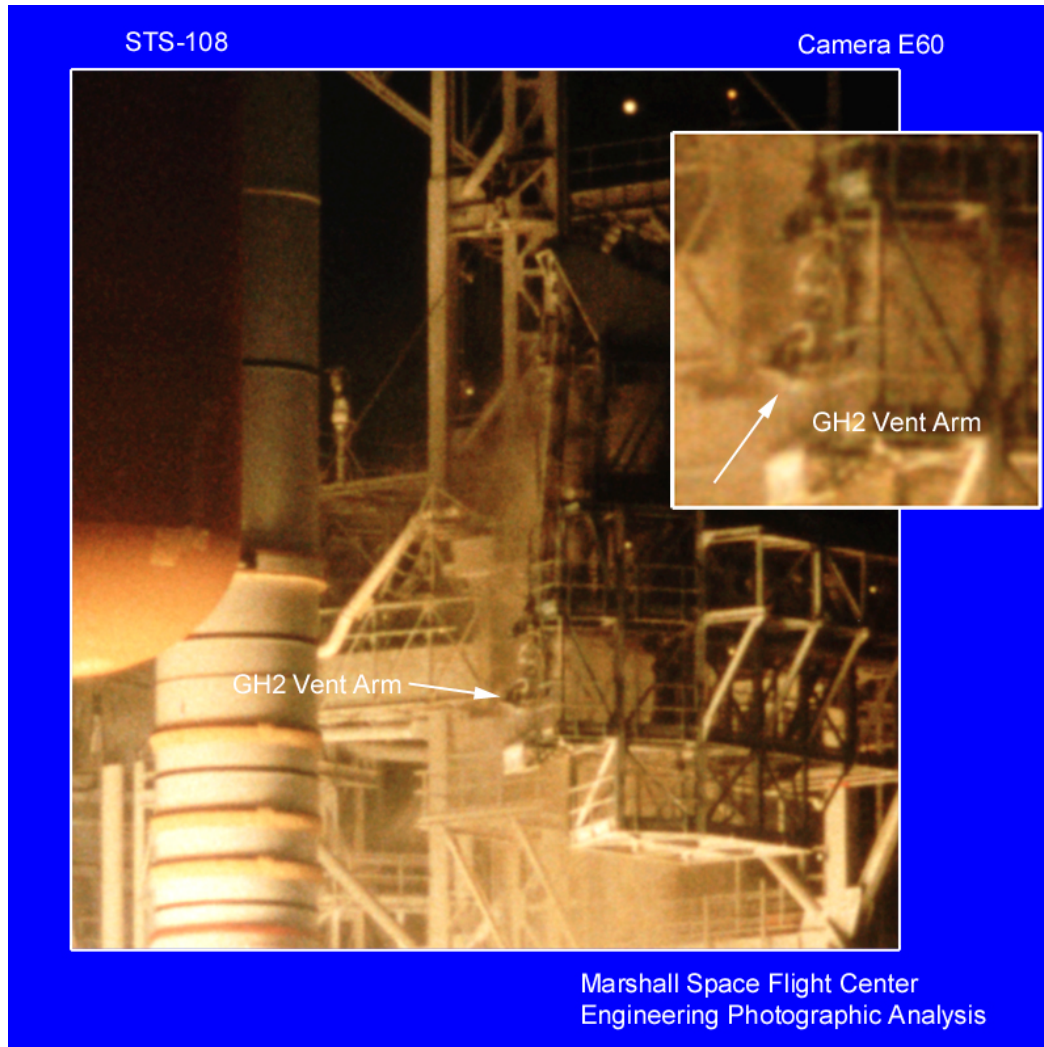
Figure 2. Film Camera E60: GH2 Vent Arm Rebound

The GH2 Vent Arm did not latch-back and the Ground Umbilical Carrier Plate (GUCP) was seen to rebound beyond the Fixed Service Structure (FSS).

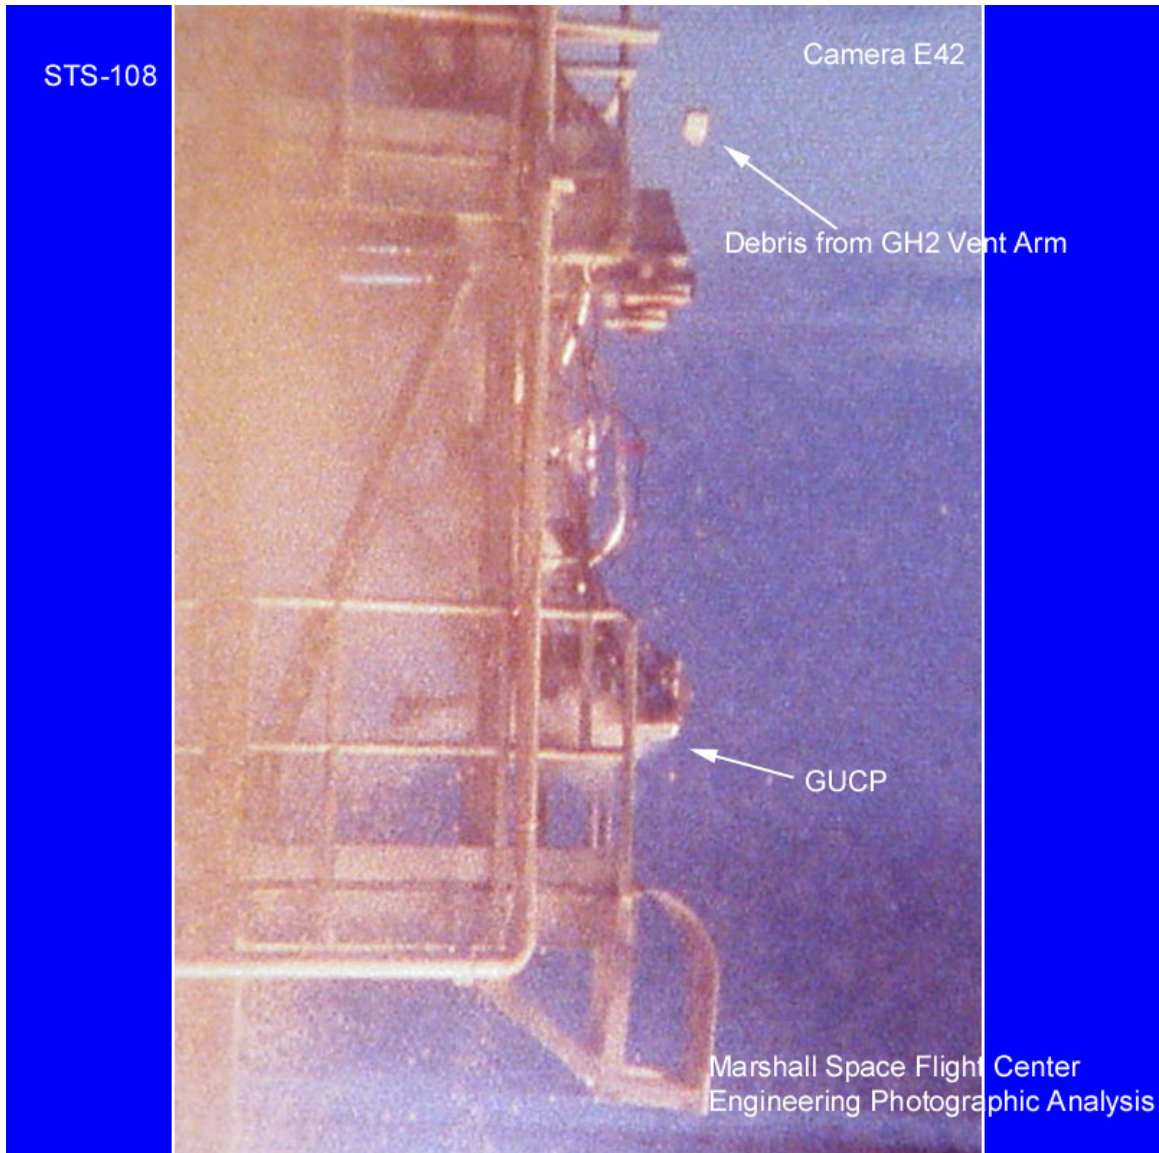
Figure 3. Film Camera E42: Debris from GH2 Vent Arm Impact

A large piece of light-colored debris (falling almost vertically downward toward the left SRB flame trench) resulting from the GH2 Vent Arm impact with the Fixed Service Structure (FSS) was observed. The debris did not impact the vehicle.

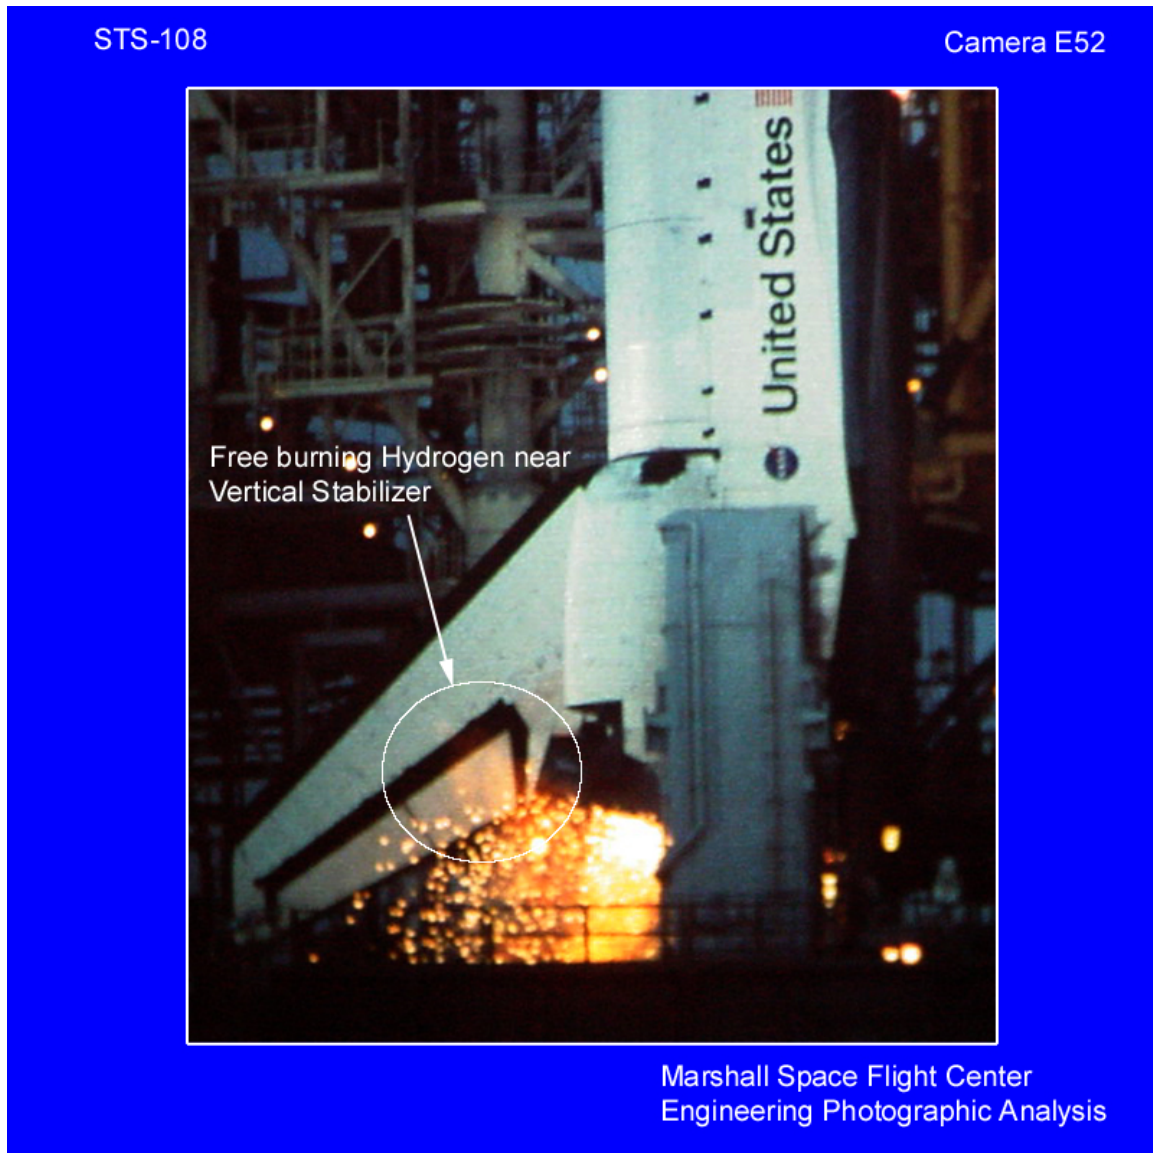
Figure 7. Film Camera E52: Free Burning Hydrogen

Free burning Hydrogen was observed at SSME ignition.

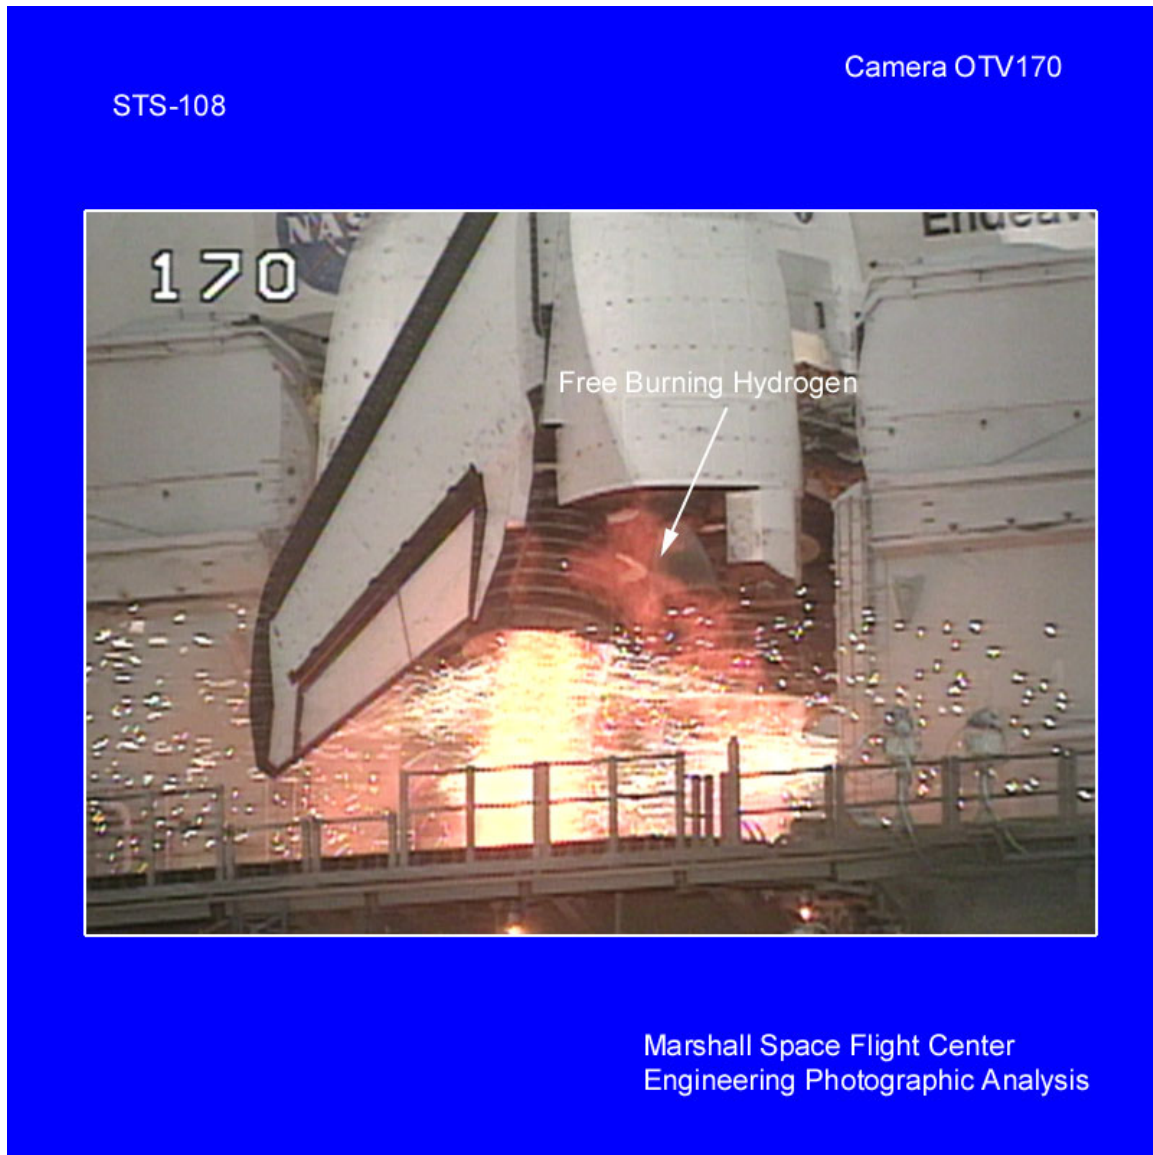
Figure 8. Video Camera OTV170: Free Burning Hydrogen

Free burning Hydrogen was observed at SSME ignition.

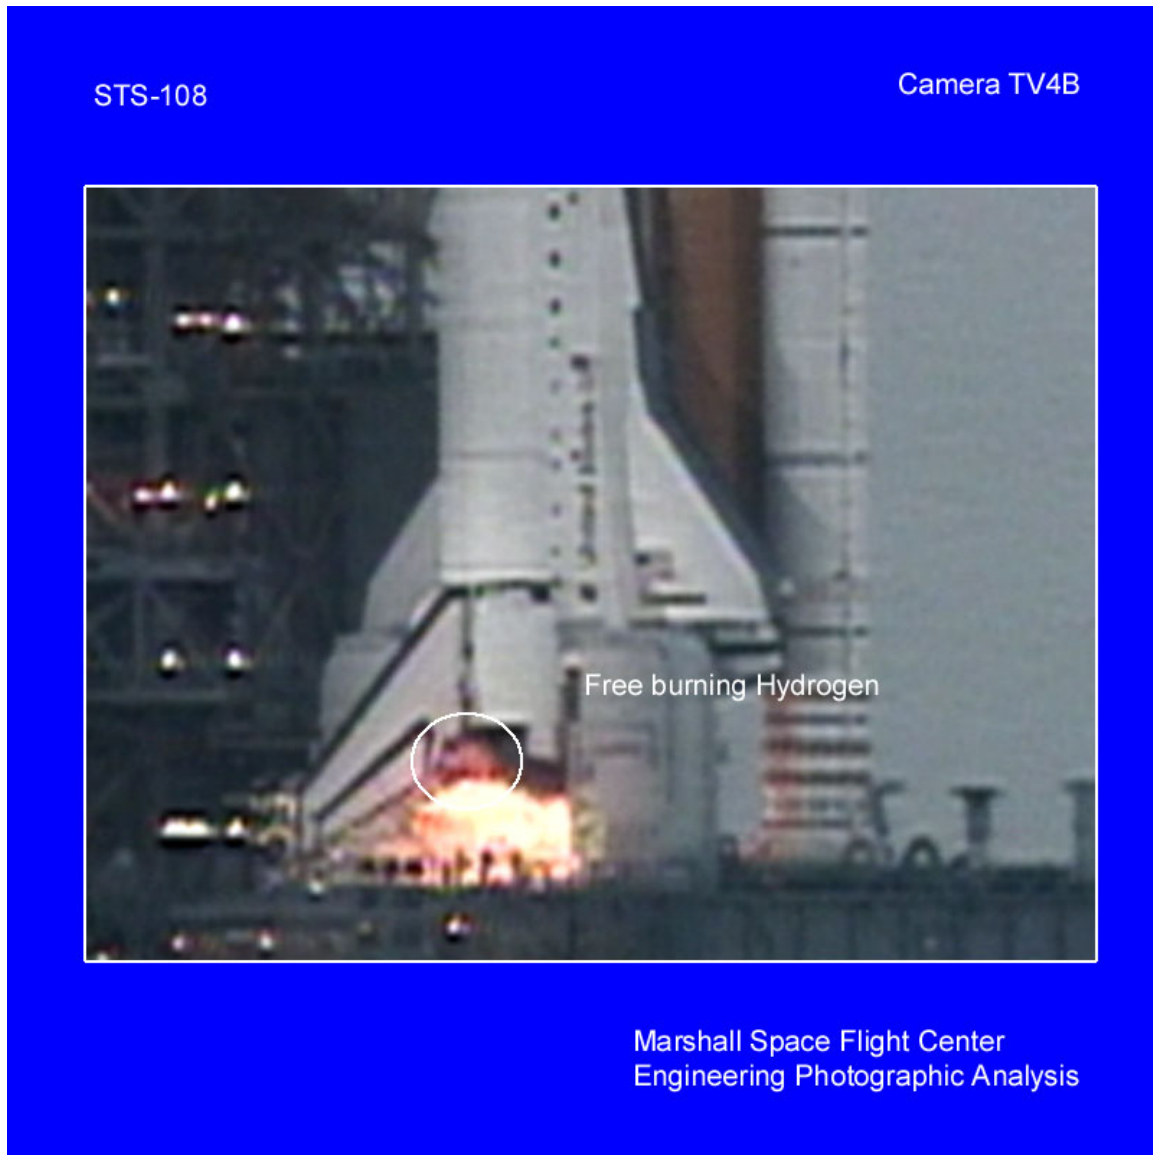
Figure 9. Video Camera TV4B: Free Burning Hydrogen

Free burning Hydrogen was observed at SSME ignition.

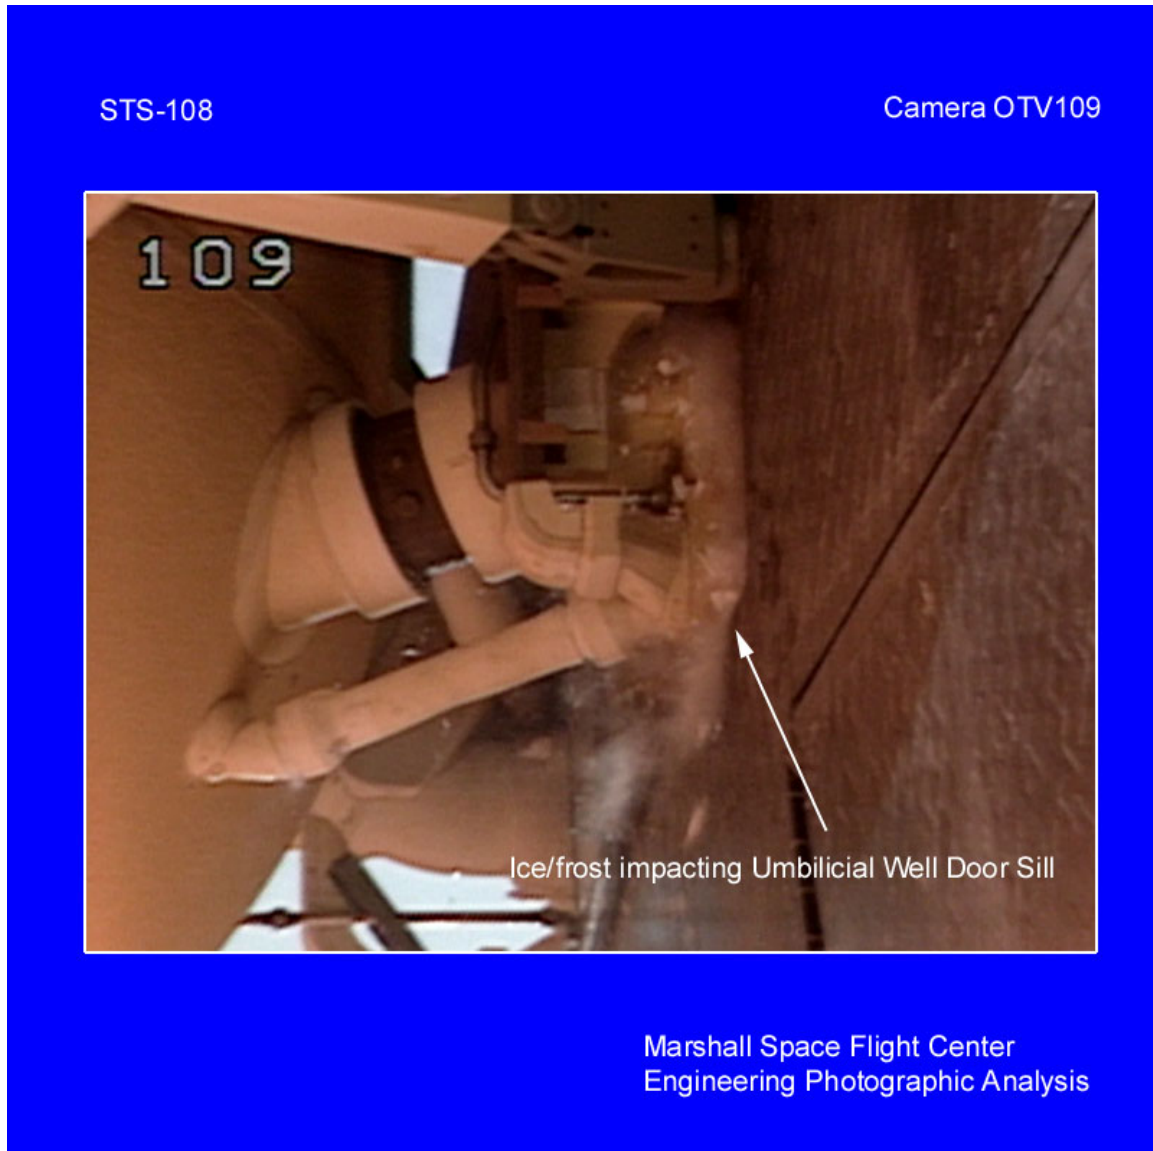
Figure 10. Video Camera OTV109: Frost/Ice near Umbilical Well Door Sill

Ice/frost impacted the umbilical well doorsill. No damage was observed.

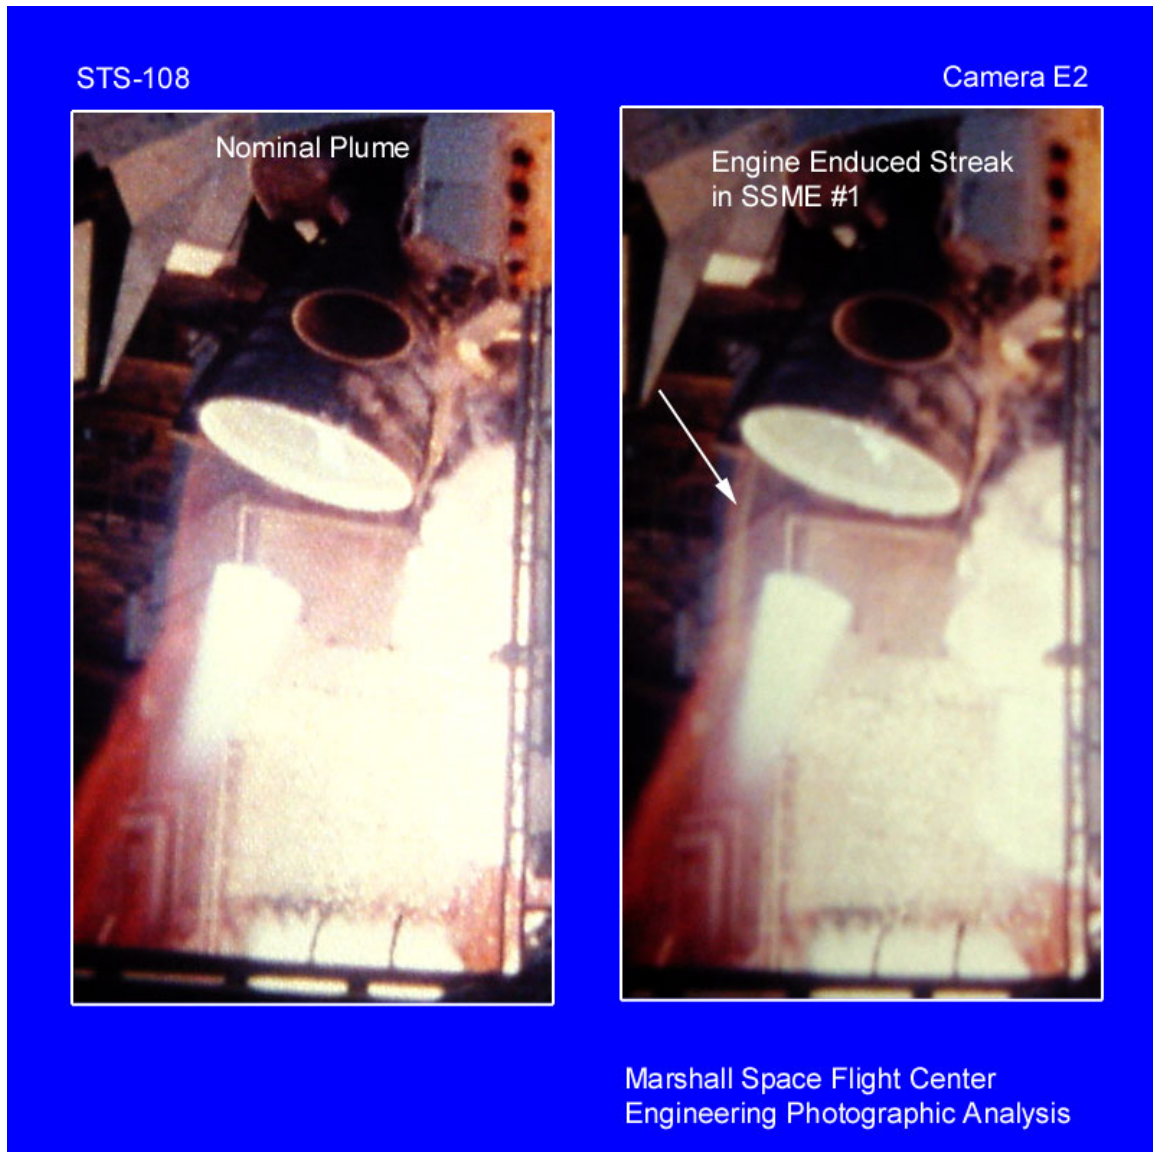
Figure 11. Film Camera E2: Engine Streak in SSME#1 Plume

An engine streak was noted in SSME #1 plume.

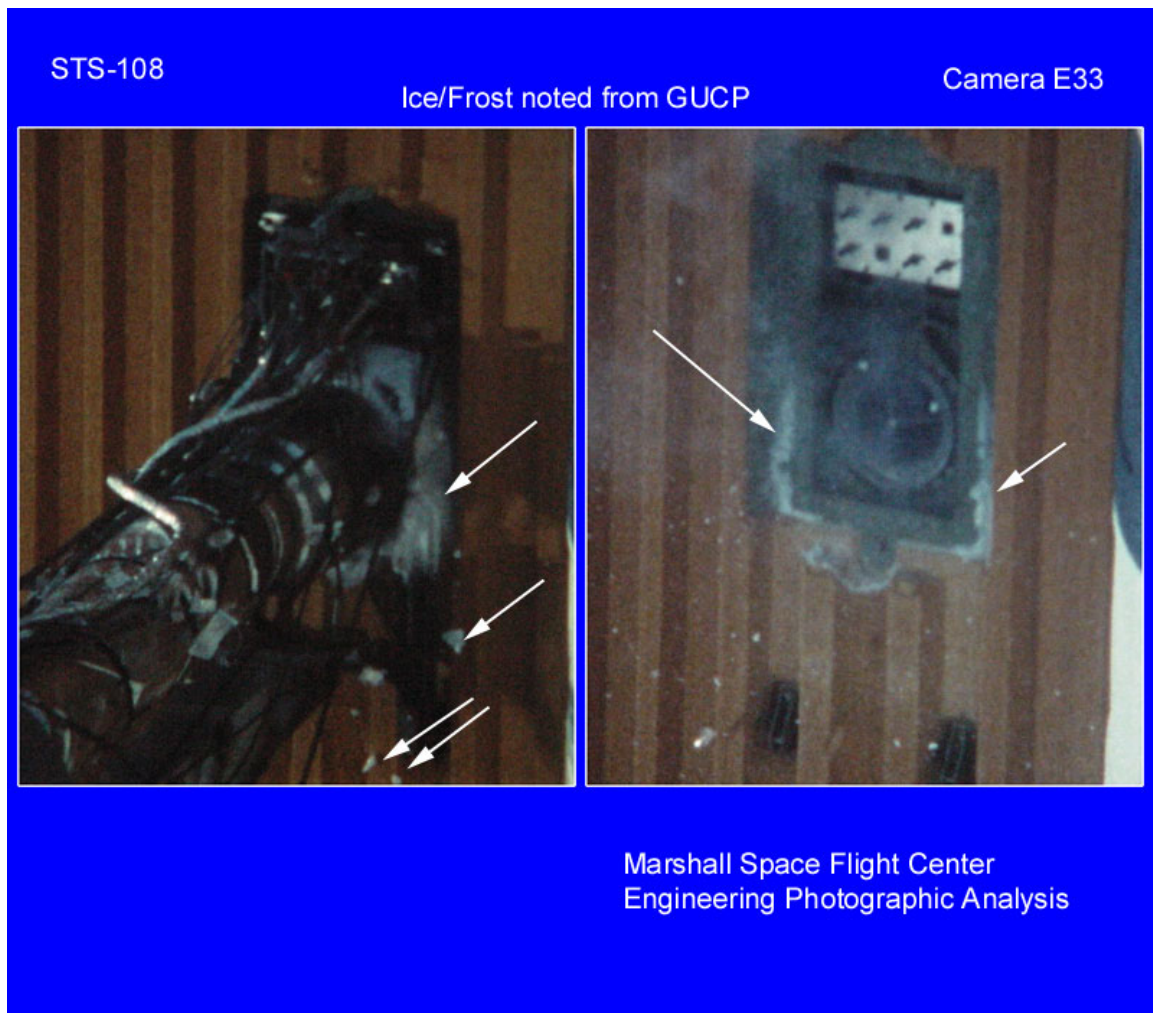
Figure 12. Film Camera E33: Frost/Ice from GUCP

Frost was noted around the periphery of the GUCA after GH2 Vent arm retraction.

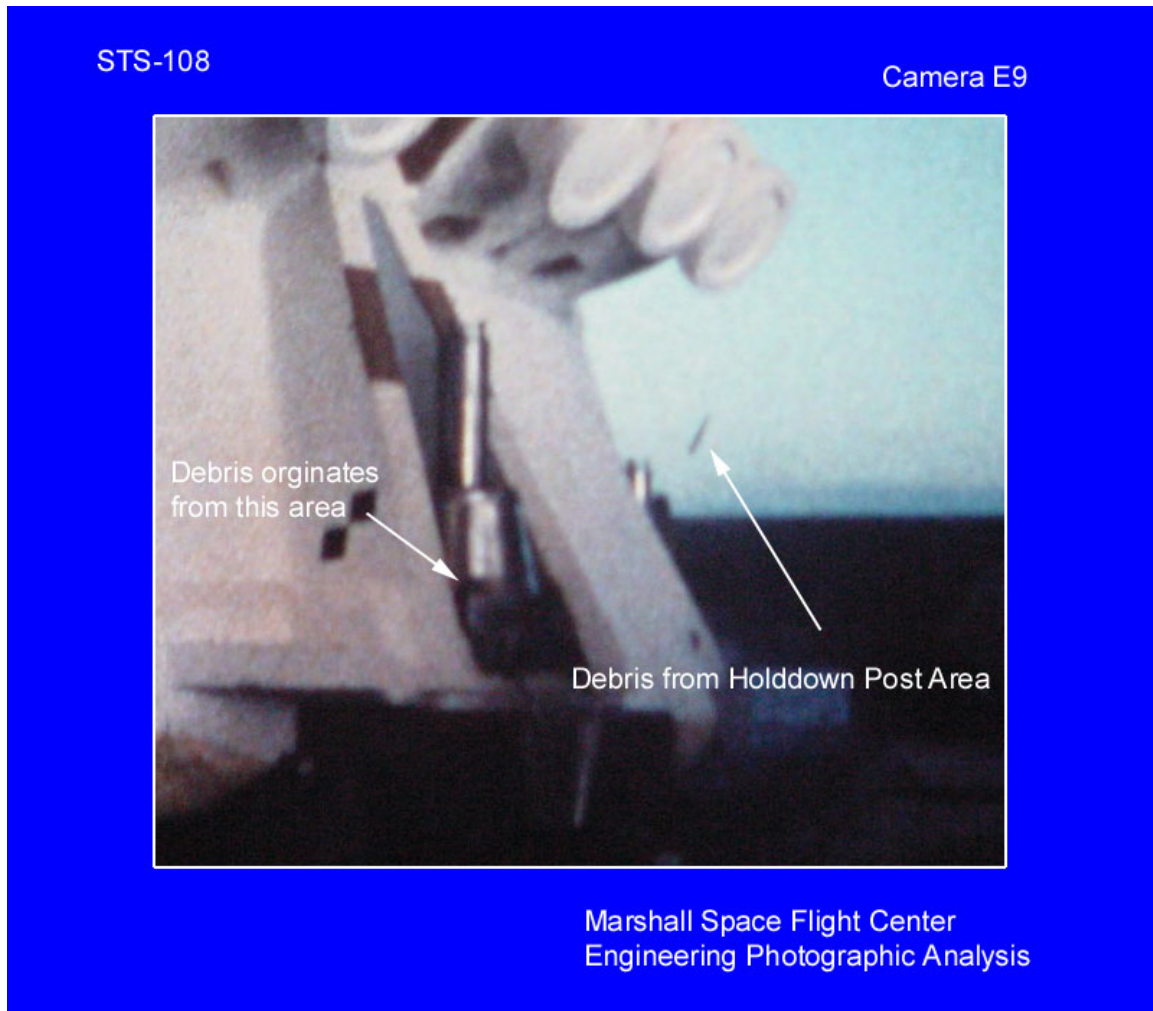
Figure 13. Film Camera E9: Debris near Holddown Post M1

Debris was observed emanating from Debris Containment System of HDP M1 just after PIC firing.

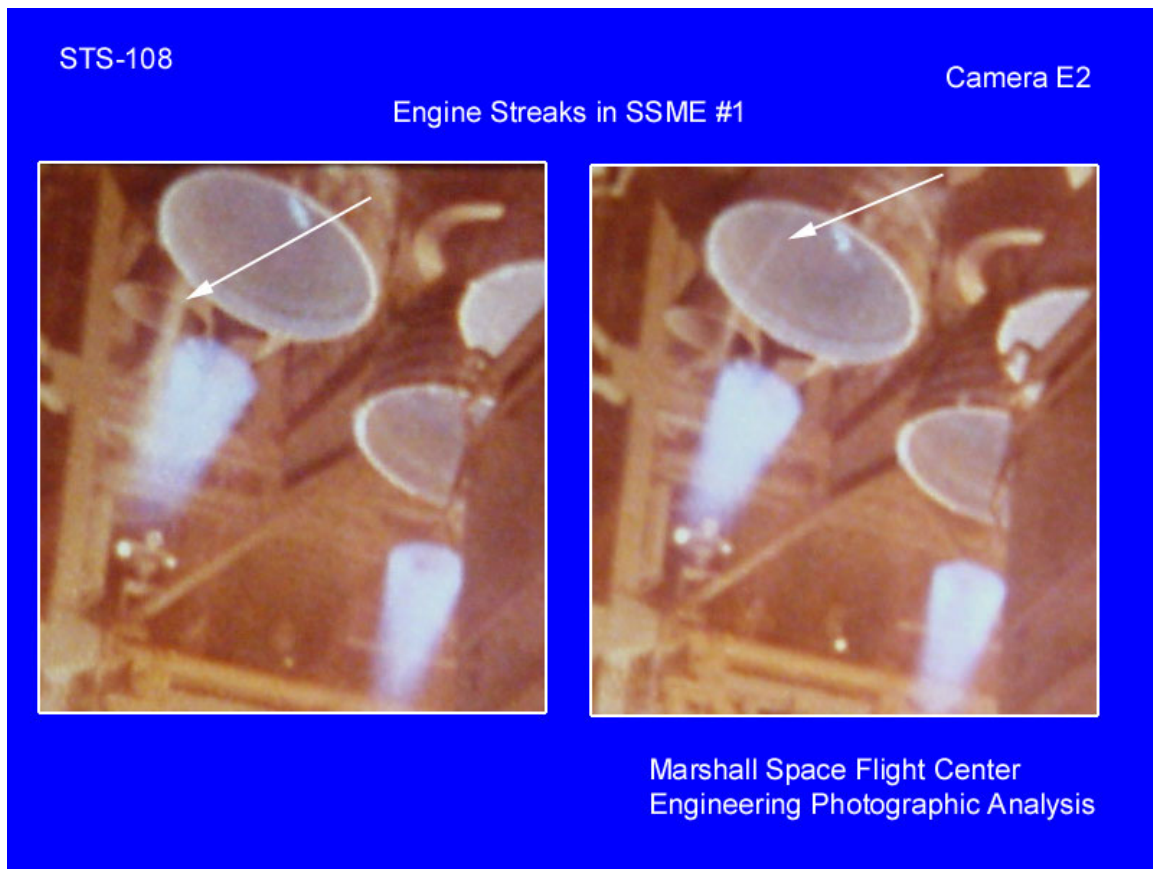
Figure 14. Film Camera E2: Engine Streaks in SSME#1 Plume

Other engine streaks noted in SSME #1 plumes.

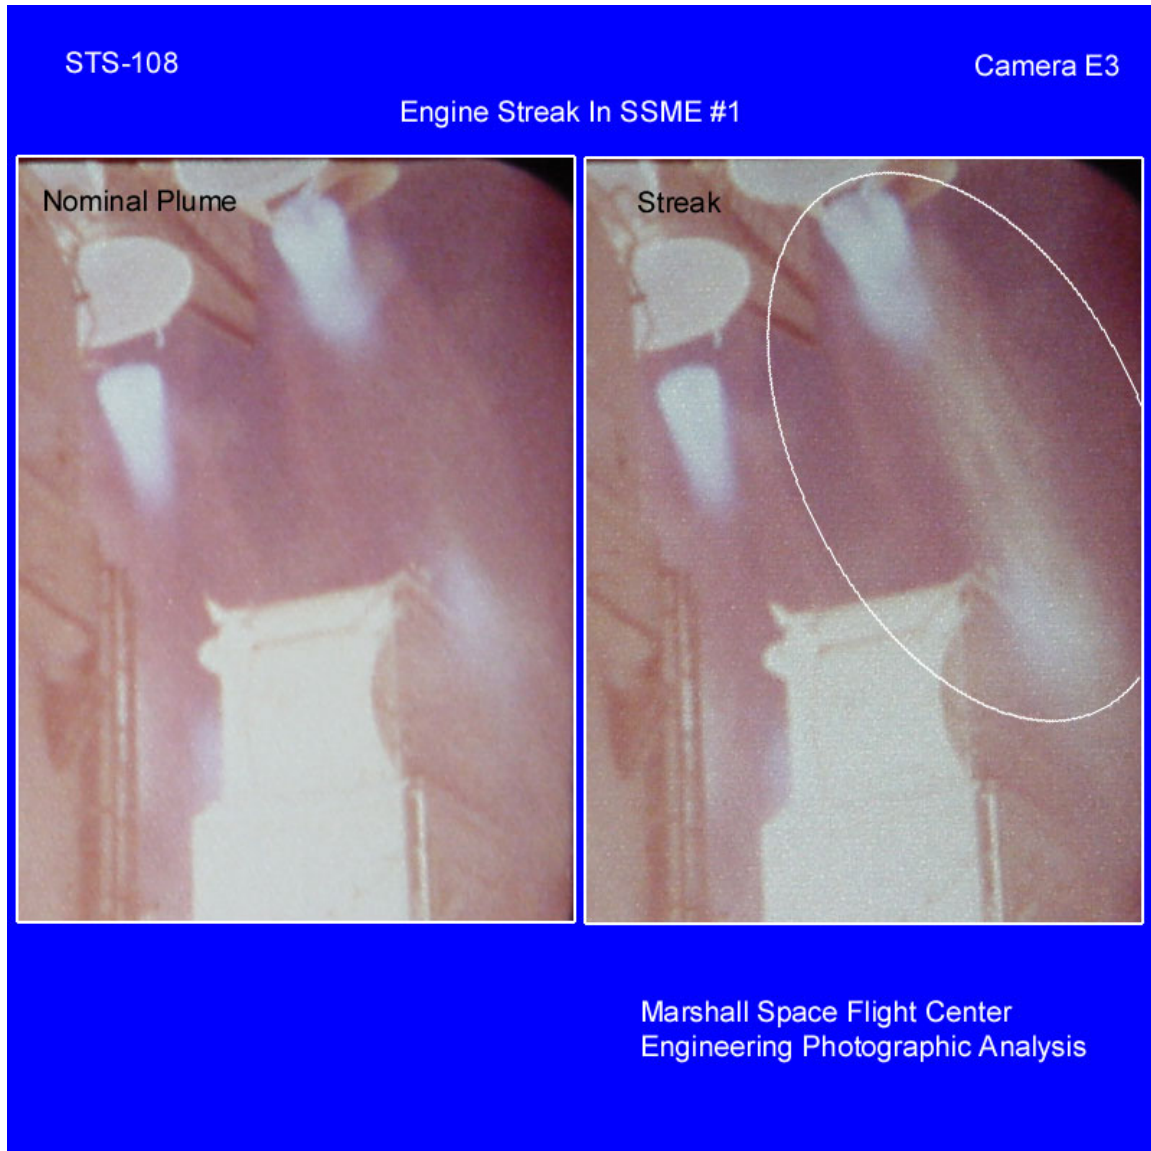
Figure 15. Film Camera E3: Engine Streak in SSME#1 Plume

An engine streak was noted in SSME #1 plume after vehicle lift-off.

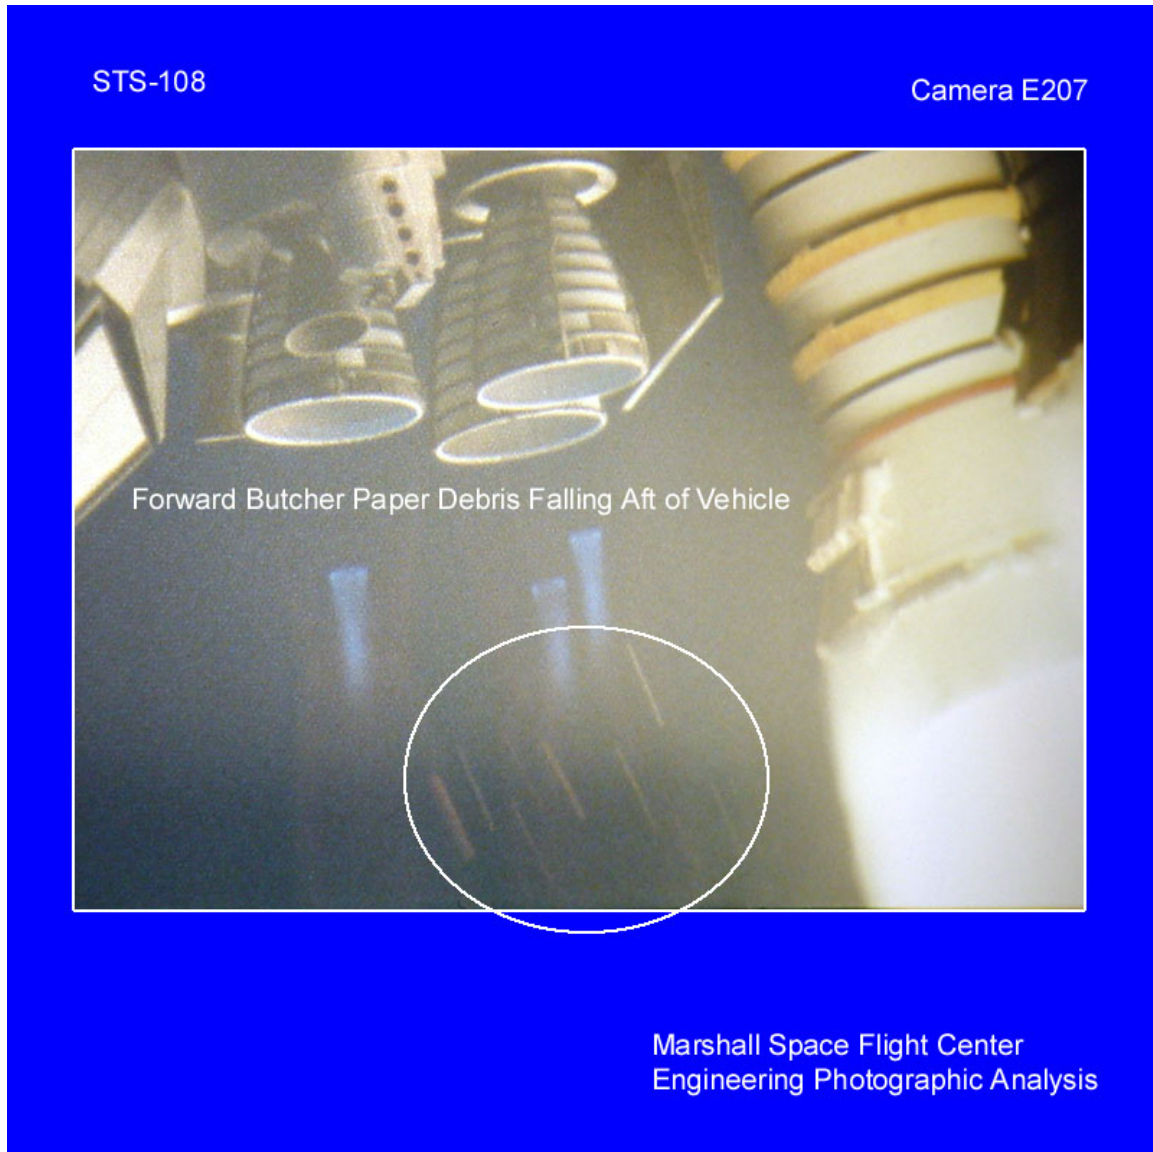
Figure 16. Film Camera E207: Debris Falling Aft

Debris was noted falling aft of the vehicle. This debris is thought to be butcher paper from the forward RCS motors.
